**U.S. Environmental Protection Agency
Vasquez Boulevard I/70 Superfund Site
Replacement Certificate**

Restoration Agreement

LBP Assessment Results

Property ID # 2646 / 3754 Delgany street

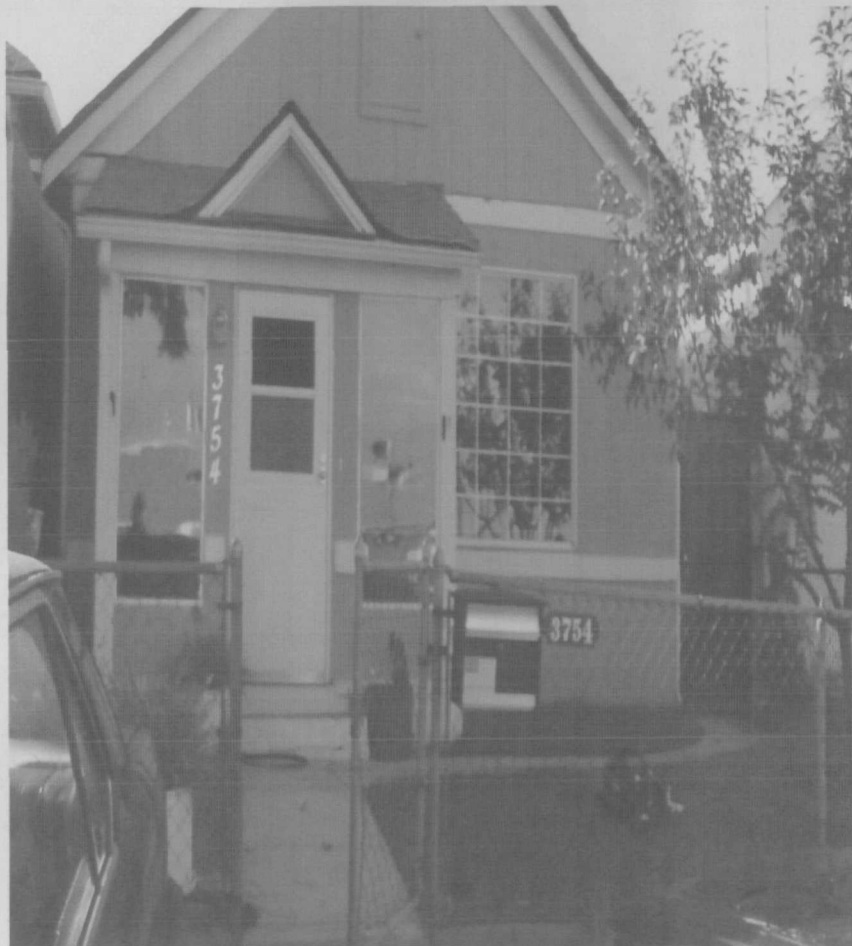
West exposure of house
